ANNUAL REPORT FOR 2003

Pembroke Creek Mitigation Site Chowan County Project No. 8.T010602 TIP No. R-2512

Prepared By:
Office of Natural Environment & Roadside Environmental Unit
North Carolina Department of Transportation
December 2003

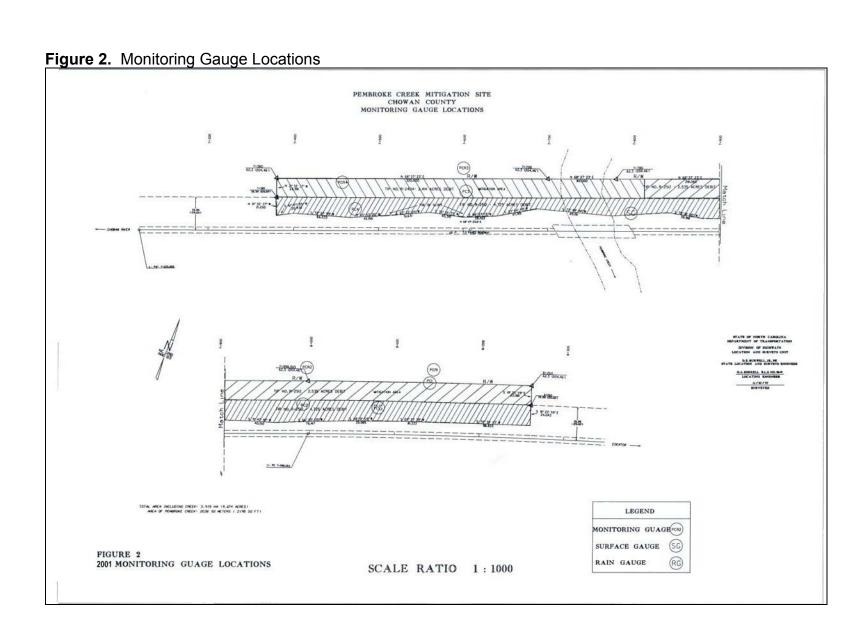
Eight groundwater-monitoring gauges (four site gauges, four reference gauges), one rain gauge, and one surface water gauge were installed onsite in February 1999; monitoring began in March 1999 (Figure 2). The automatic monitoring gauges and rain gauges record the depth to groundwater and rainfall, respectively. Data was collected on a daily basis throughout the growing season.

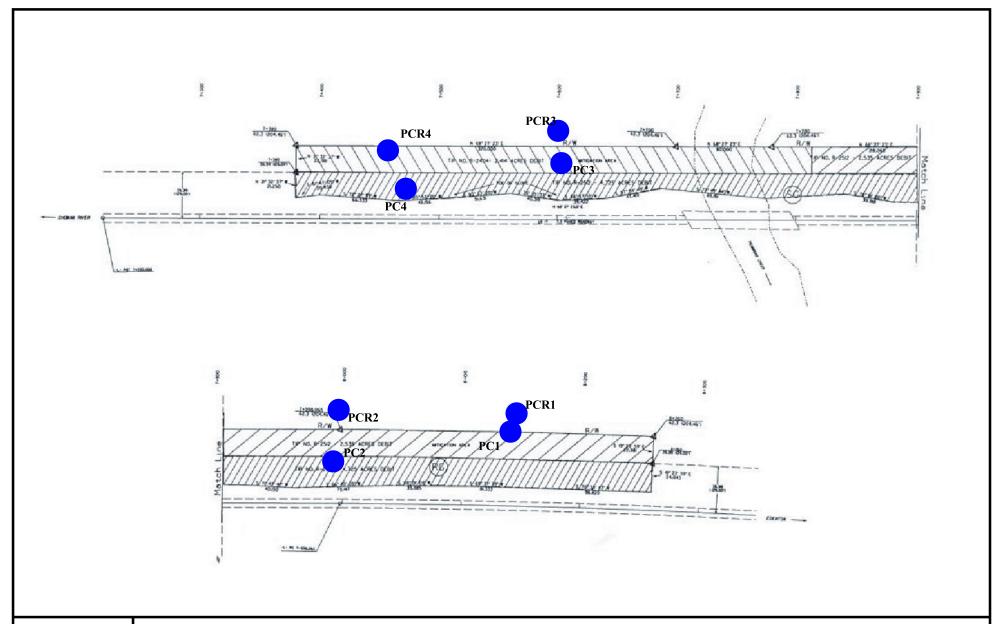
Figure 3. 2003 Hydrologic Monitoring Gauge Results

The maximum number of consecutive days that the groundwater was within twelve inches of the surface was determined for each gauge. The number of days was then converted into a percentage of the 262-day growing season. Table 2 and Figure 3 give the results for the 2003-growing season (March 13-December 1).

Hydrology Results

- < 5%
- 5 8%
- 8 12.5%
- > 12.5%

The hydrologic monitoring results for the 2003-year indicate that the site is successful by jurisdictional standards. The mean saturation percentage of the onsite gauges (85.4%) fell within 20% of the mean for the four reference wetland gauges (100%). The 2003-year represents the fifth consecutive year for hydrology monitoring, therefore NCDOT proposes to discontinue hydrology monitoring on the Pembroke Creek Mitigation Site.

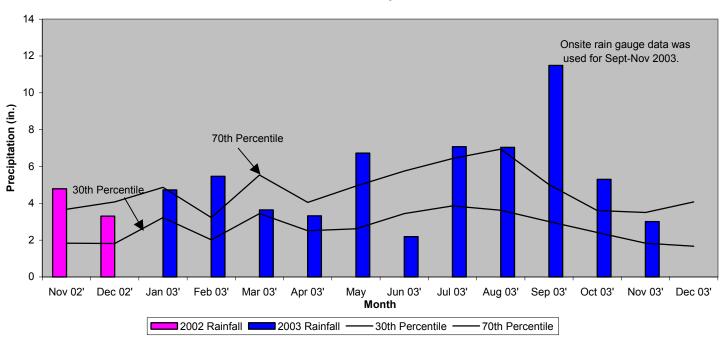
Figure 4. 30-70 Percentile Graph

Figure 4 is a comparison of 2003 monthly rainfall to historical precipitation for the Edenton area. Rainfall data recorded onsite during the growing season was compared to the historical 30-70 percentile trends for the area. It is assumed that if the 2003 rainfall totals, represented by bars, fall between the average precipitation values for each month, then the local climate was experiencing average conditions for that particular region.

For the 2003-year, the only month to experience below average rainfall was June. The months of December (02'), January, March, April, and November all recorded average rainfall for the site. November (02'), February, May, July, August, September, and October experienced above average rainfall. The onsite rain gauge was used for the months of September-November 2003. Overall, 2003 experienced an average rainfall year.

Pembroke Creek 30-70 Percentile Graph Edenton, NC Monthly Rainfall

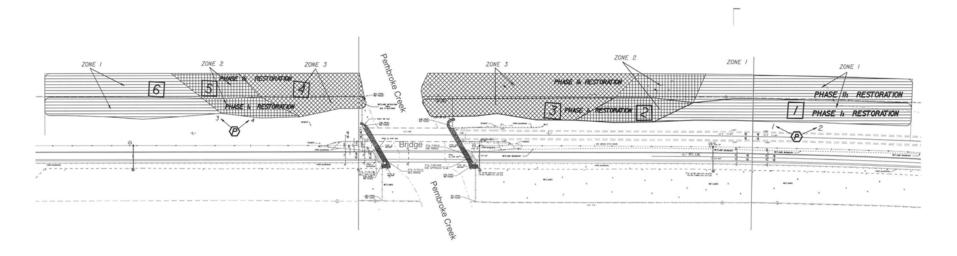
Pembroke Creek Mitigation Site Planting Plan, Plot Locations, and Photo Locations

Plot Locations

Photo Locations
